# SERVICE BULLETIN

## 3" Pump Changes

Model Series Affected: LM2350E-X

RELEASED: 10-28-98  
REVISED: 1-10-12  
REV: 00  
BULLETIN: #6-98  
FORM: 4303-2

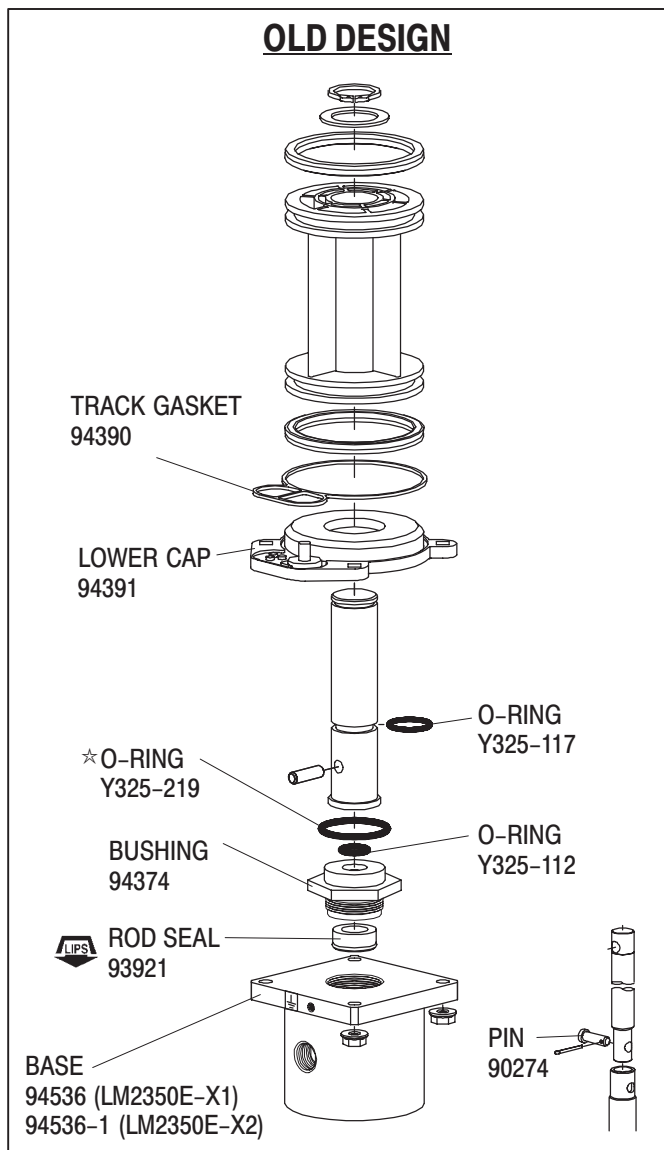
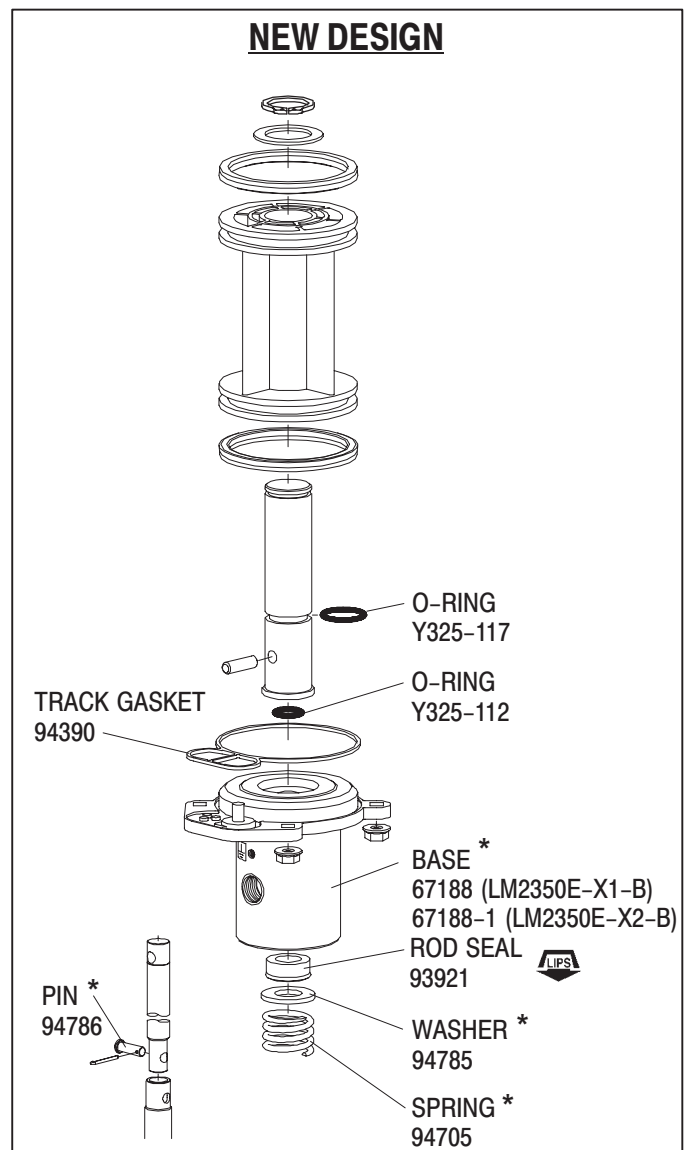
**NEW PUMP BASE DESIGN** - A new design eliminates the lower cap part. This part is now incorporated into the new base design. Parts indicated by (\*) are all required to update to the new design.

- 1) Parts eliminated: Lower Cap 94391 (Incorporated into new Base), Bushing 94374, O-ring Y325-219.  
NOTE: 637227-B Service Kit is used for repair all models. This kit includes a ☆Y325-219 O-ring which is not used on LM2350-X-B models.
- 2) Parts added: Spring 94705, Washer 94785.
- 3) Part change: Pin 90274 (.890) to Pin 94786 (.781), the new shorter pin is required to fit inside the new spring.
- 4) The Rod Seal 93921 moved to the bottom side of the Base.
