SERVICE BULLETIN

Two-Ball Pump Changes

LOWER PUMP ENDS AFFECTED: 66300-X

RELEASED: 4-9-99
REVISED: 1-10-12
REV: 00
BULLETIN: #3-99
FORM: 4319-2

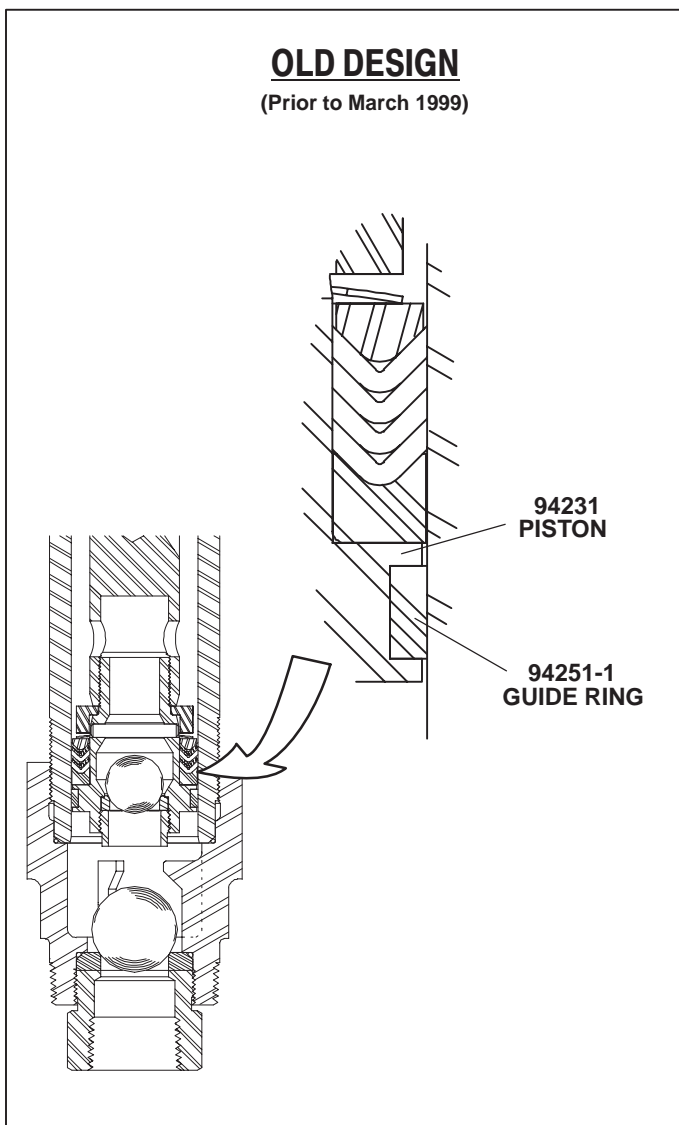
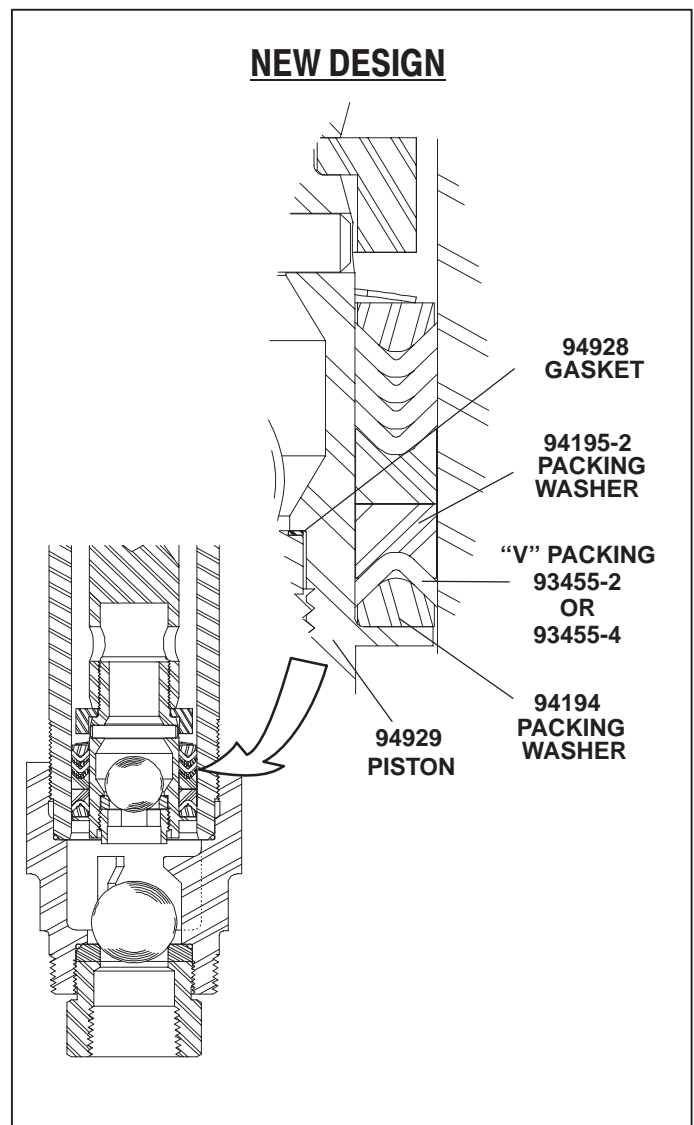
HARDENED PISTON AND REDESIGN WITH ADDITIONAL WIPING V-PACKING.

The following changes were made to 66300-X Lower Pump End.

- 1) 94231 Piston replaced by new design 94929 Piston.
- 2) Add 94928 Gasket.
- 3) 94251-1 Guide Ring removed.
- 4) 93455-2 or 93455-4 Packing added as appropriate for model.
