# SERVICE BULLETIN

## Four-Ball Pump Changes

LOWER PUMP ENDS AFFECTED: 6720X-X

RELEASED: 3-29-99  
REVISED: 1-10-12  
REV: 00  
BULLETIN: #4-99  
FORM: 4321-2

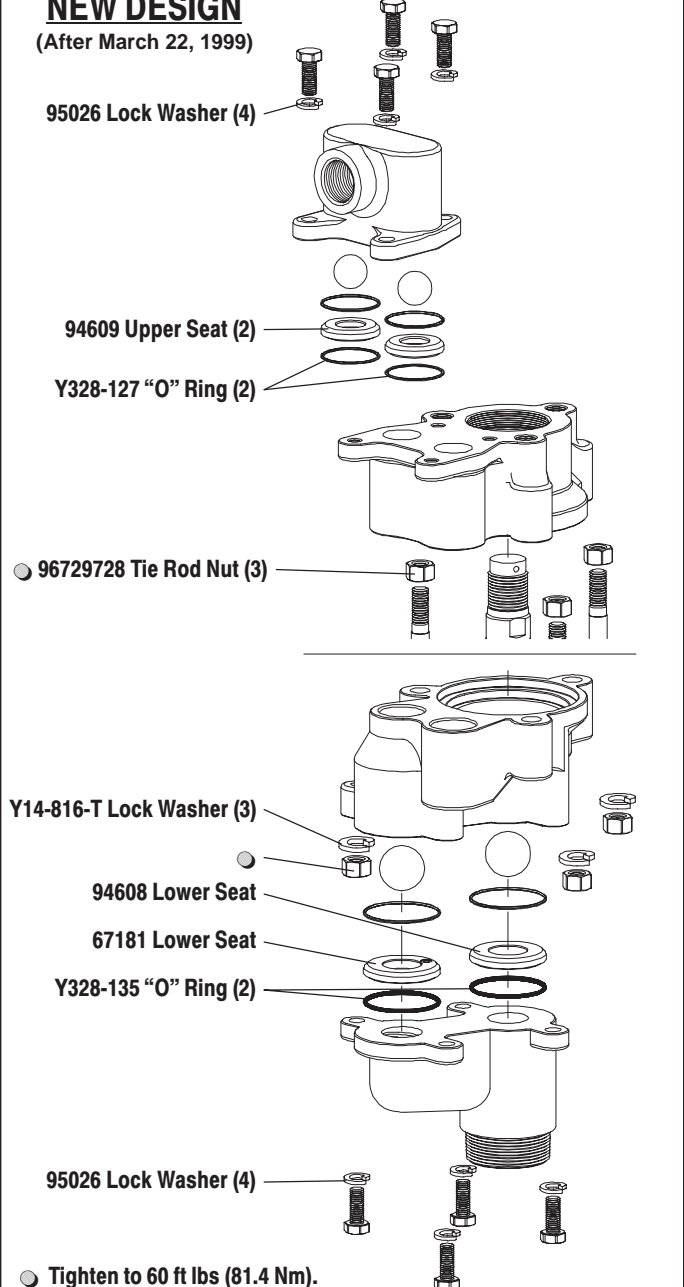
### NEW DESIGN

(After March 22, 1999)

- 1.) Add 95026 lock washers (8).
- 2.) Add Y14-816-T lock washers (3).
- 3.) Add 96729728 tie rod nuts (3).
- 4.) Y328-29 "O" rings (2) are replaced by Y328-127 "O" rings (2).
- 5.) Y328-33 "O" rings (2) are replaced by Y328-135 "O" rings (2).
- 6.) 67181, 94608 and 94609 (2) seats have a larger machined shoulder to accept larger "O" rings.
