# SERVICE BULLETIN

## Four-Ball Pump Changes

LOWER PUMP ENDS AFFECTED: 6720X-X

RELEASED: 7-6-99  
REVISED: 1-10-12  
REV: 00  
BULLETIN: #5-99  
FORM: 4336-2

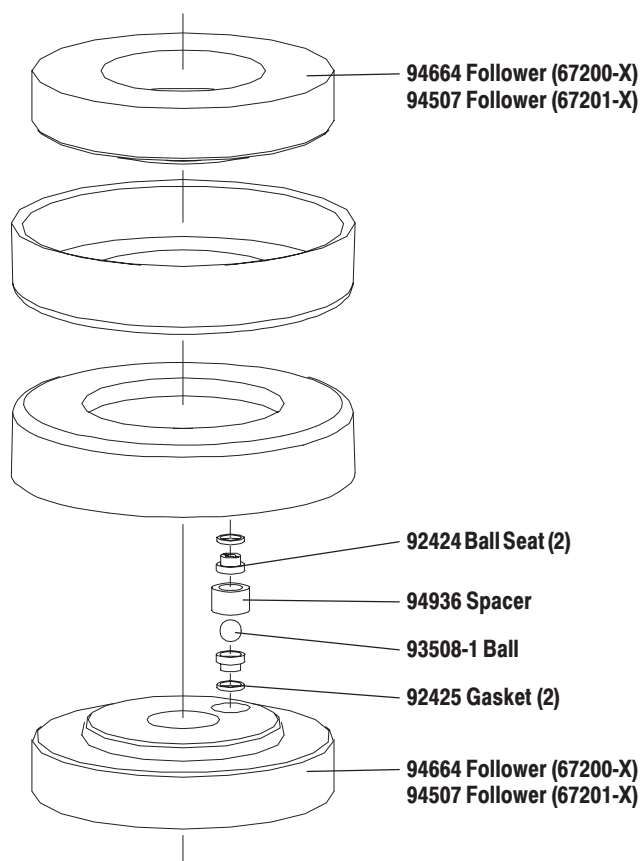
### NEW DESIGN

(After June 30, 1999)

- 1.) Add 92425 gaskets (2).
- 2.) Add 92424 ball seats (2).
- 3.) Add 93508-1 ball.
- 4.) Add 94936 spacer.
- 5.) 94507 and 94664 followers are machined to accept the items listed above.
