SERVICE BULLETIN

FP2009-001 Revision 0 04-Sept-2009

ARO-Flo, 2000 Series - Regulators and Filter/Regulators Torque Adiustment

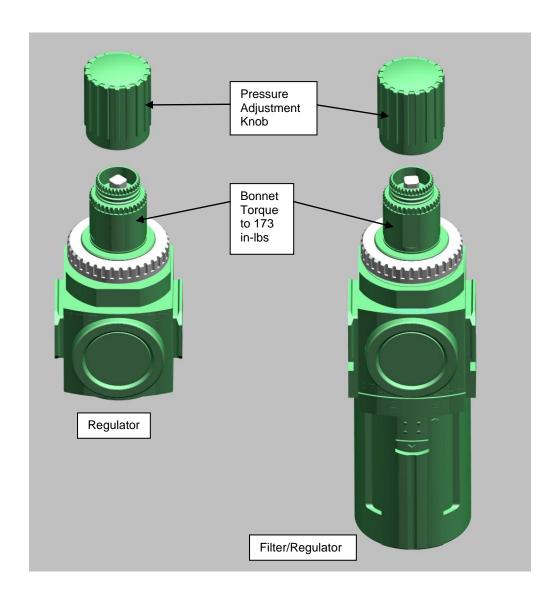
Under certain operating conditions (i.e. cyclic loading) the units may experience a loss of adjustability or excessive leakage due to the control diaphragm moving out of position.

There is a field repairable procedure for unused units, as follows (see illustration on next page):

- 1.) WARNING: Depressurize all upstream and downstream pressure from the system (If unit is installed). Reference Product Safety Information Manual (100400-53).
- 2.) Fully rotate the Pressure Adjustment Knob counter-clockwise to remove all internal spring tension.
- 3.) Remove the Pressure Adjustment Knob by pulling outward from unit.
- 4.) Using a calibrated torque wrench, torque the Bonnet to 173 in.-pounds.
- 5.) Reinstall the Pressure Adjustment Knob.
- 6.) Place unit back into service.
