Problem:

Temperature control system can not hold temperature steady.

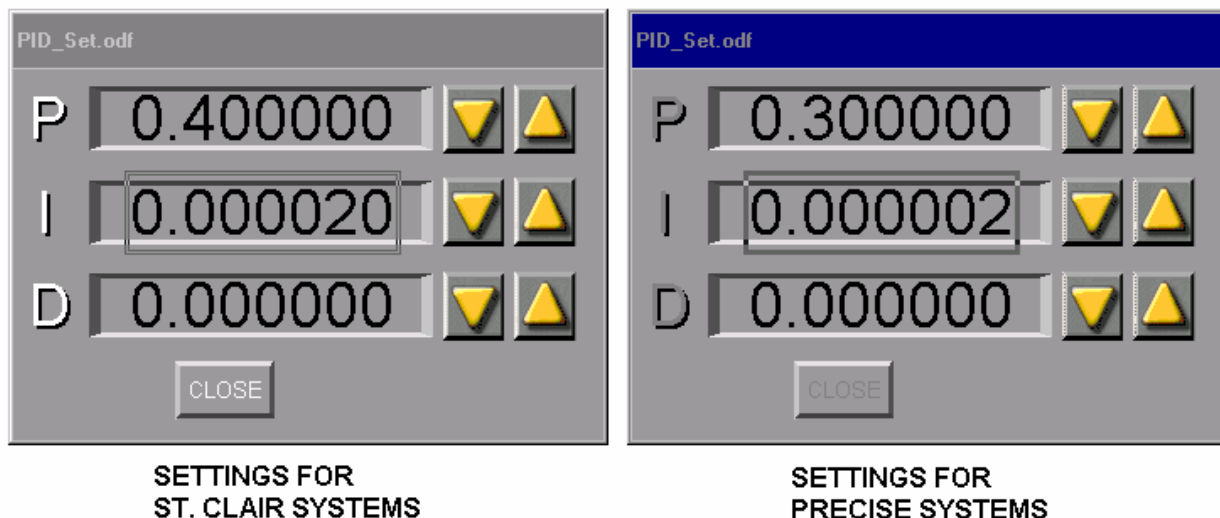
Figure 1

The temperature fluctuates constantly, varying more than ± 5 degrees F. The variation in temperature contributes to the variation in volume being dispensed.

The PID values for the temperature controller are not optimized.

Set the PID values as shown in figure 1.

1. Copy TEMP-FIX.EXE to AutoStream hard drive and execute. This installs new PID entry screens.
2. In the settings screen of the AutoStream software, tap the PID button on the Temperature Controller.
3. Enter the values shown in Figure 1.

The new settings **will** stabilize the temperature so that it does not fluctuate greater than ± 2 deg F.
The actual temperature **will** be lower than the set point.
