Problem:

- A) The screen on the Insight Graphics Units (PFS1-G and PFS2-G) does not update, but the system continues to run.
- B) Message “Unable to communicate to Spindle Control Module” appears.
- C) Message “Communicating with SCM(s)” remains on the screen.

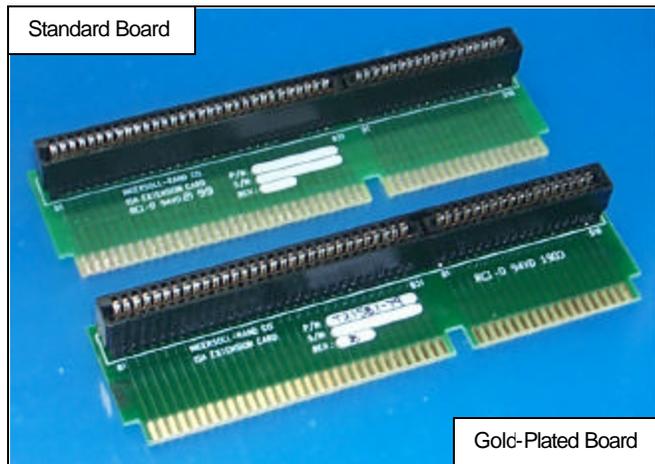
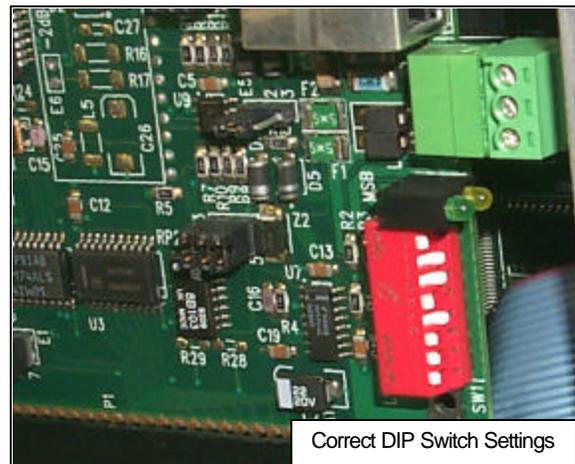
The ISA Extension Board that connects the Arcnet Board to the back of the Computer is not providing good continuity to all of the contacts. This could be because of thermal expansion, corrosion, or particle contamination.

Gold plated contacts are much less susceptible to contamination than the standard contacts used on the ISA extension board.

T21581-79 is the part number for the gold plated ISA Extension Board.

- 1) Turn off power to the Insight.
- 2) Remove plexiglass cover from the back of the PC Computer.
- 3) Remove the Arcnet Board (on the right with the red DIP switches and green connector).
- 4) Discard the old ISA Extension Board and replace with the gold-plated board.
- 5) Install the Arcnet board (make sure the DIP switch settings do not change).
- 6) Replace the plexiglass cover.
