SERVICE INSTRUCTIONSARO MODEL
635029DESCRIPTION

TYPE-----Manual Air Control Valve

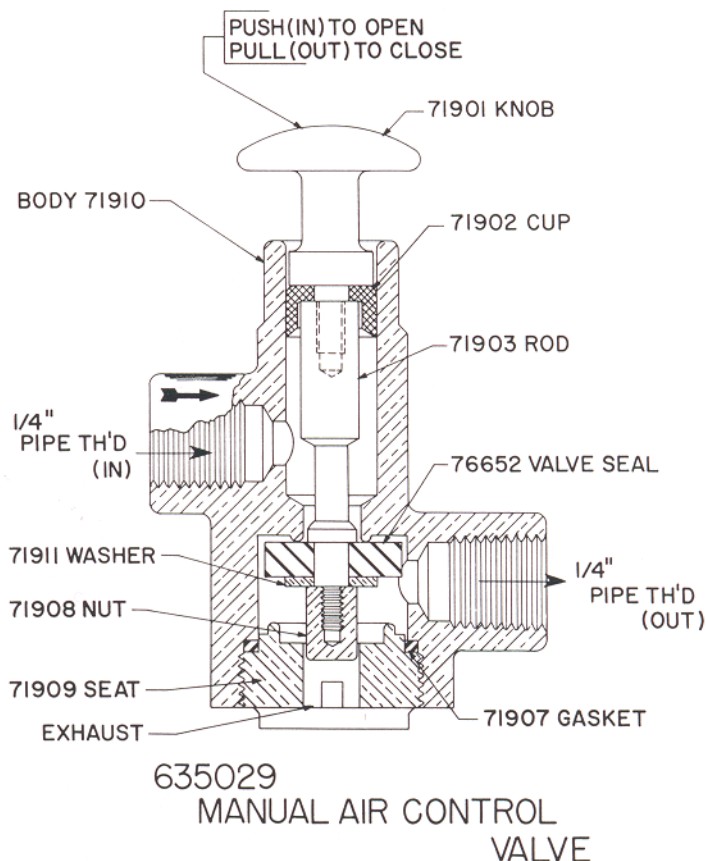
1. Remove the 635029 manual air control valve ass'y. from the air line.
2. Remove 71909 seat.
3. Remove 71908 nut.
4. Pull 71901 knob, 71902 cup, and 71903 rod from 71910 body.
5. Clean seating surfaces.
6. Check 76652 valve seat for cuts or other damage to sealing faces. Replace valve seat if cut or damaged.
7. To replace damaged or leaking 71902 cup, remove 71901 knob from 71903 rod (right hand threads).

Reassemble in the reverse order that the 635029 air valve was disassembled.

1. If valve is leaking air at 71901 knob end of the valve, squirt some oil on 71902 cup, and actuate valve a few times. If this does not stop the leakage the 71902 cup will have to be replaced.

2. If valve is leaking at exhaust end (71909 seat) the valve will have to be disassembled to clean dirt from seating surfaces and replace 76652 valve seal if damaged.
