2:1, 4:1 OR 7:1 RATIO 35 LB. PAIL 611301 and 611302 HAND OPERATED PUMPS

611301 611302 HAND OPERATED METERED GEAR LUBRICATOR

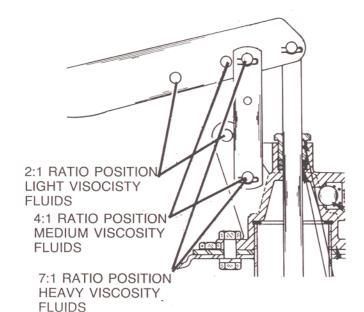
MULTI-PURPOSE HAND OPERATED PUMP RATIO ADJUSTMENT

The ARO multi-purpose hand operated pumps are designed so the ratio can be easily adjusted to handle any viscosity fluid.

The diagram illustrates the location of the linkage to obtain any one of the three different ratios.

The lower the ratio set, the more volume of fluid will be dispensed with each stroke. However, the heavier the viscosity of the fluid, the higher the ratio should be and the volume per stroke will be reduced accordingly. Therefore, the unit should be set at the ratio at which you receive the most volume and the unit still operates with an easy stroking effort. When using the model 611301 or 611302 to fill the Aro–Pak, we recommend 7:1 ratio. On other applications, set at most efficient operation.

Install handle. The linkage hook—up shown in service drawing on reverse side illustrates the 7:1 ratio and this pump will generally work best at this setting. The paragraph on ratio adjustment will aid you in deciding which ratio you should use and the numbers stamped on the handle and the pump will guide you in making the setting. Example: Should you desire a 4:1 ratio, simply connect 72027 Link to pump at position marked "4" and to handle, also, at position marked "4".

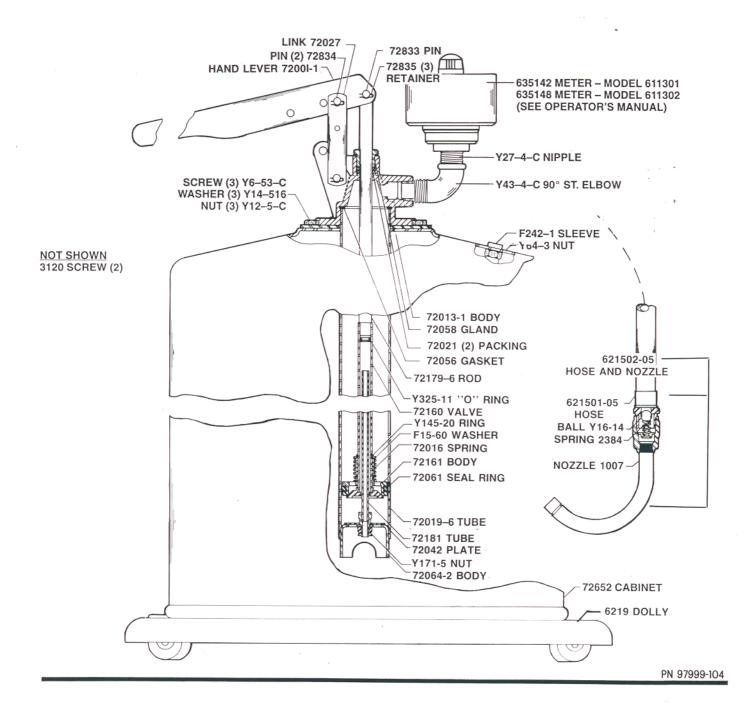
CAUTION: Always install 72027 link so cross pin is closer to handle than to pump (see drawing).

- If you are unable to operate pump, the ratio setting may be too low for material being pumped. If this is not the case, check suction tube for damage or obstruction.
- If pump operates, but dispenses little or no lubricant, remove Y171–5 Nut, 72064–2 Body and 72042 Plate, and check for foreign matter which may be holding plate 72042 off seat. Also, make sure plate or seat is not bent or scored.
- If leakage occurs between plunger rod and 72058 gland, tighten gland just enough to stop leakage. Do not over-tighten – causing excessive packing wear.
